**MATERIALS-COOLANT INTERACTIONS
RELEVANT TO EBR-II**

**W. E. Ruther, T. D. Claar,
S. Greenberg, and R. V. Strain**

EBR-II Project

April 1971

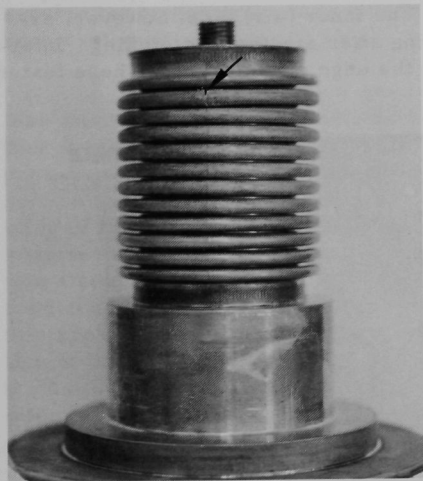
Visual examination of the bellows (see Fig. 1) revealed a large crack on the outer ply of the second convolution from the end of the bellows nearest the ball. The crack was at the exact spot where the outer ply had been formed over the resistance-welded seam of the inner ply. The outer ply was plastically deformed in this area during fabrication. Figure 2 shows a magnified view of the crack.

Fig. 1. Bellows from Vent Valve S2-VC-1590 of Secondary System, Showing Large Crack Responsible for Sodium Leak. Mag. $\sim 0.85X$. Neg. No. MSD-52562.

Since no evidence was found to indicate that interaction of stainless steel with the EBR-II secondary sodium was responsible for the initiation of the leak, it is postulated that a defect in the outer (sodium) ply was present as a result of the manufacturing process. This initial leak allowed sodium to interact with the small amount of air contained between the two plies of the bellows. The resulting increase in oxygen concentration in the sodium in this isolated region would account for the grain-boundary oxidation along the edge of the crack. The sodium of increased oxygen concentration caused intergranular penetration and embrittlement of both plies in this area. The embrittled inner ply then failed during a subsequent operation of the valve, thereby allowing sodium to gain access to more air inside the bellows body. As the sodium increased again in oxygen concentration, intergranular cracking and extreme deterioration of the inner ply occurred.

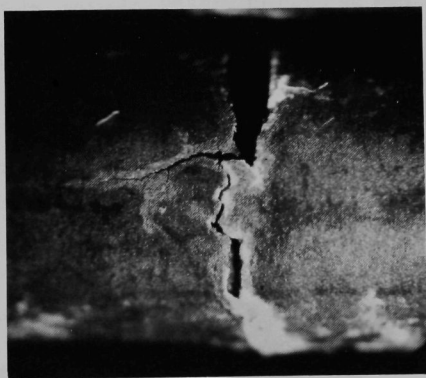
Fig. 2. Magnified View, from Sodium Side, of Crack in Bellows from Vent Valve S2-VC-1590. Mag. $\sim 13X$. Neg. No. MSD-52563.

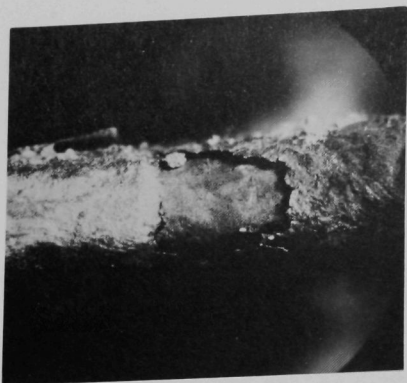
Fig. 3

The inner bellows ply near the region of the crack exhibited extreme brittleness and deterioration. The inner ply had been completely destroyed in several regions (see Fig. 3).

Inside (Air Side) of Bellows from Vent Valve S2-VC-1590 in Vicinity of Large Crack, Showing Deterioration and Tearing of Inner Ply. Mag. ~13X. Neg. No. MSD-52564.

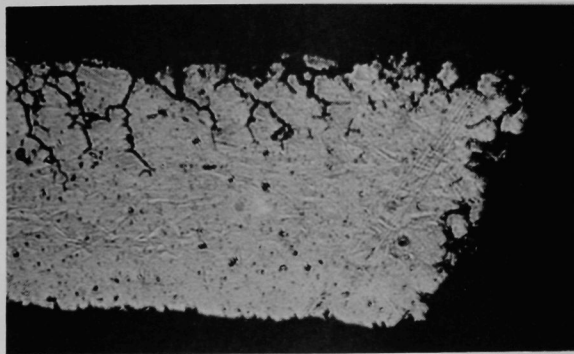
A metallographic section was taken through the crack in the outer ply by grinding along the axis of the bellows. The outer (sodium) surface showed essentially no attack. The inner (air) side, however, exhibited intergranular attack and cracking after electrolytic etching. Intergranular attack was also evident along the edge of the crack. These features can be seen in Fig. 4.

Fig. 4. Transverse Section through Large Crack in Outer Bellows Ply of Vent Valve S2-VC-1590, Showing Intergranular Attack. Inner ply has been completely destroyed in this region. (10-sec etch in 5% oxalic acid). Mag. 250X.

The metallographic evidence suggests that a small perforation originated in the outer (sodium) ply because of defective bellows material or local stress concentrations. Large localized stresses could have been caused by the plastic deformation introduced into the outer-ply material either when it was formed over the weld seam of the inner ply or possibly during its service lifetime. The bellows was deformed $1/2$ in. lengthwise in service, or about 27% of its free length. A 20% maximum deformation is a typical value suggested by manufacturers for a bellows of this type. Thus, the actual deformation was about 135% of that suggested. The bellows operated at about 15 psi, which is roughly 10% of its rated capability. When these values are used on the bellows-lifetime nomograph supplied by a bellows manufacturer,⁴ a projected life of about 8000 cycles may be expected. Although this nomograph was derived from room-temperature data, exposure of 770°F would not be expected to significantly decrease the life of a stainless steel bellows.

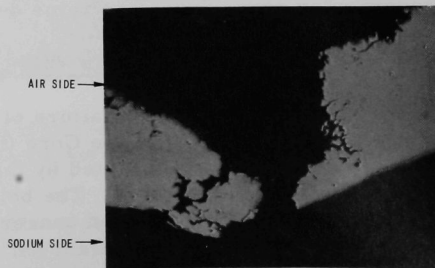
Fig. 6

Microscopic study of the specimens from the defect areas showed that the inner surface (air side) of the bellows had been corroded extensively, with the loss of surface grains (see Fig. 6), while the outer

Section through a Defect Site of Bellows from CCTL Drain-line Valve, Showing Corrosive Attack on Air Side (as polished). Mag. 275X.

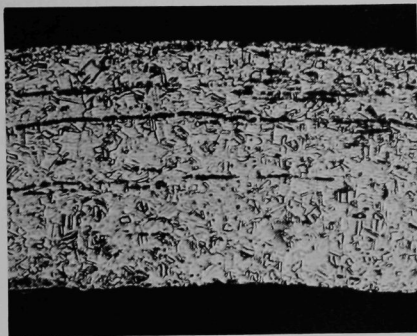
Fig. 7. Typical Network of Nonmetallic Inclusion Stringers in Bellows from CCTL Drain-line Valve (10-sec etch in 5% oxalic acid). Mag. 375X.

The most striking aspect of the microstructure of the stainless steel was the considerable quantity of nonmetallic inclusions present in the material. The inclusions were in the form of long stringers rather than of discrete particles and were in greater abundance than is typical of stainless steel of good quality. The morphology, size, and quantity of inclusions in a typical transverse bellows section can be seen in Fig. 7. These inclusions were apparent in all sections of the bellows examined--not just in isolated areas.

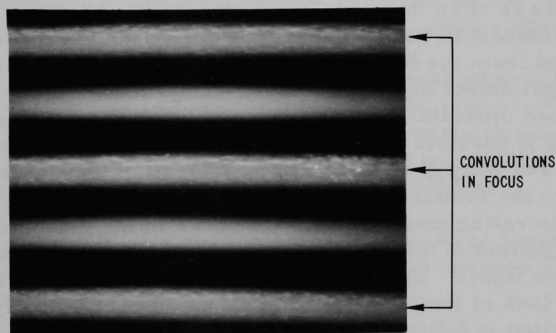
The most interesting feature of the radiographs was the presence of image lines running circumferentially along the convolutions, as shown in Fig. 8. All convolutions radiographed showed the same general features,

Fig. 8. Magnified Print of X-ray Radiograph of Bellows from CCTL Drain-line Valve, Showing Image Lines of Inclusion Stringers. Mag. 5.25X.

but in some areas the lines formed heavier networks or clusters. This effect was especially apparent adjacent to the previously noted defect sites. In addition to the clustering effect in these regions, dot-like images were noted, which suggests that the features of the metal responsible for the images were also oriented axially in certain areas.

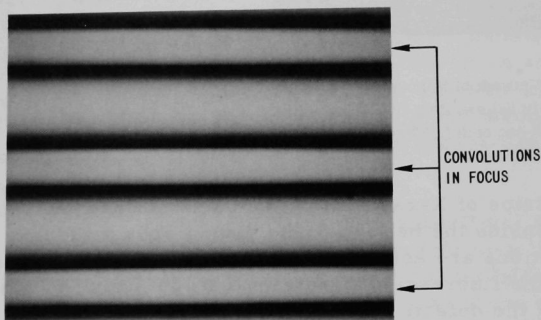
Comparison of the results of radiography and metallography suggested that the nonmetallic inclusions in the stainless steel produced the X-ray images. The image lines and inclusion stringers were oriented in the same direction and had approximately the same size and frequency of appearance. Also, both the inclusions and the images were found generally throughout the bellows. A similar stainless steel bellows containing few, if any, inclusion stringers did not produce any linear or network images when radiographed (see Fig. 9).

Fig. 9. Magnified Print of an X-ray Radiograph of Bellows with a Clean Microstructure. Note absence of image lines of inclusion stringers. Mag. 5.25X.

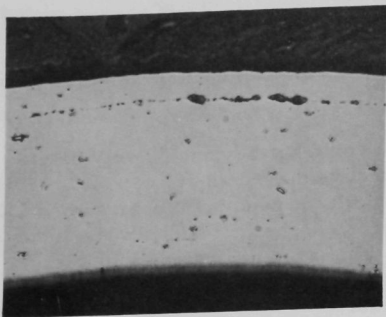
The suspect area for the bellows exposed to liquid sodium did show an unusual density of inclusions in stringer form (see Fig. 10) and possible microporosity.

Fig. 10. Inclusion Stringers in Suspect Region of Bellows Exposed to Sodium in Flowmeter Calibration Equipment (as polished). Mag 325X.

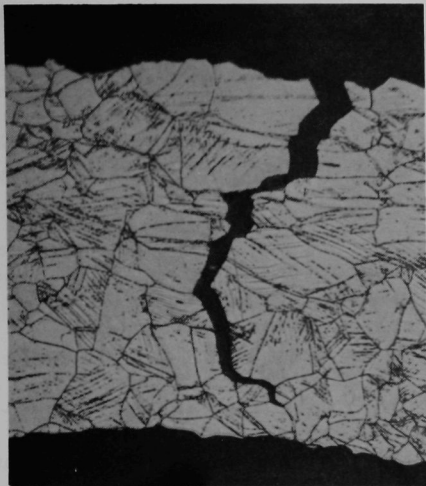
Fig. 11. Crack through Middle Ply of Bellows Valve Life-tested at 1200°F, Showing Intergranular Separation (10-sec etch in 5% oxalic acid). Mag. 350X.

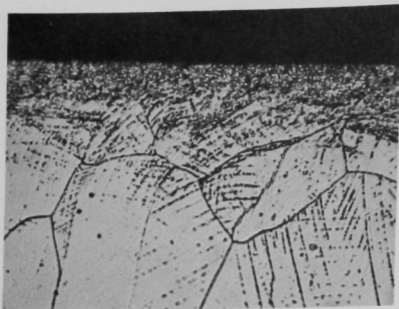
In the as-polished condition, a thick oxide coating was present at the outer surface (air side) of the Type 316 stainless steel Swagelok fitting; below this oxide, a subsurface reaction layer was also found. Etching with oxalic acid revealed that this layer contained nitride precipitates (see Fig. 12); they were similar to the nitrides formed in Type 304 stainless steel foils during exposure to nitrogen at 1020°F for 1 week.

Fig. 12. Type 316 Stainless Steel Swagelok Fitting from Overheated Sodium Sampler (5-sec etch in oxalic acid). Mag. 750X. Neg. No. MSD-51996.

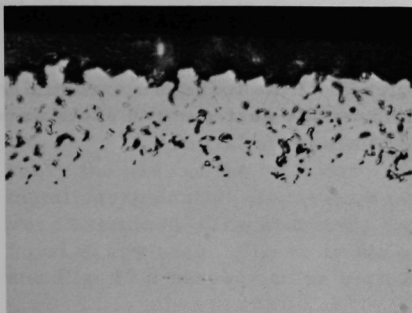
Fig. 13. Portion of Type 304L Stainless Steel Level-detector Probe Exposed to Sodium (as polished). Mag. 750X. Neg. No. MSD-52000.

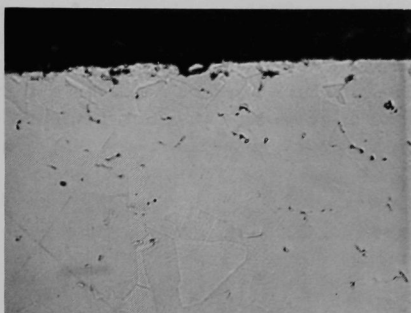
Fig. 14. Portion of Type 304L Stainless Steel Level-detector Probe Exposed to Argon above Sodium (as polished). Mag. 750X. Neg. No. MSD-52001.

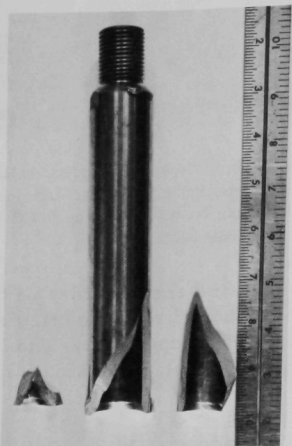
cylinder, which resulted from the accidental impact on an upper adapter fixture. Note that one crack goes through the smear. An analysis of the surface of the metal smear indicated that the smear was stainless steel. The fracture surfaces and the exterior surface of the tool were essentially free of corrosion product, although occasional tiny rust-colored spots were on the fracture surface.

Fig. 15. Shattered Cylinder of Lead-cutting Tool for Instrumented Subassemblies

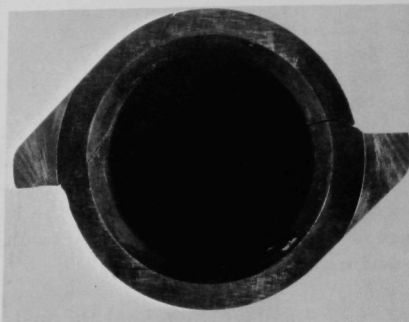
Fig. 16. End View of Pieced-together Lead-cutting Tool

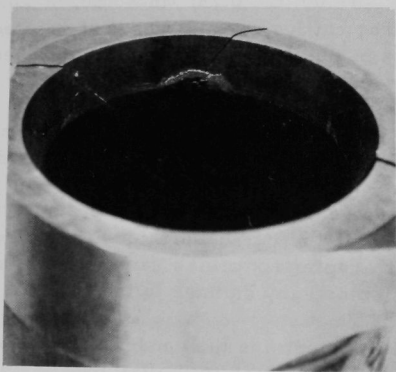
Fig. 17

Oblique View of Lead-cutting Tool,
Showing Smeared Metal inside Cylinder

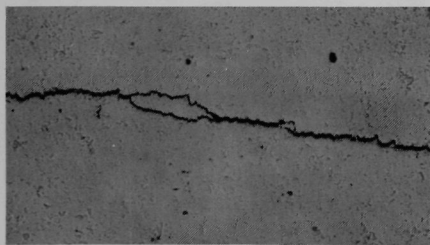
Material at the tip of the large V-shaped fracture (about $2\frac{5}{8}$ in. above the base of the tool) and at the tip of the axial crack was examined metallographically. Sections parallel to, and perpendicular to, the tool axis were examined. The branching typical of stress-corrosion cracks was not found in any case. Figure 18 shows a longitudinal view of the axial crack, and Fig. 19 a perpendicular section at the base of the crack.

Fig. 18. Longitudinal View of Axial Crack in Cylinder of Lead-cutting Tool (as polished). Mag. 75X.

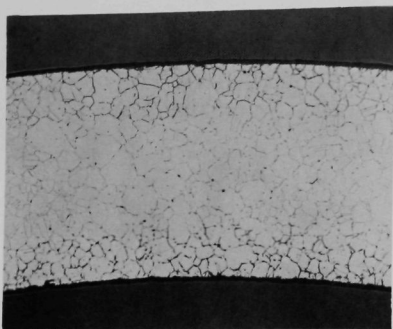
Metallographic examination of samples of fuel-element cladding to determine the effects of the reactor primary sodium and the sodium-removal operation on Type 304L stainless steel continued throughout the year. Samples of Mark-IA driver fuel elements having fluences up to 3.5×10^{22} nvt and of Mark-II driver fuel elements having fluences up to 3.3×10^{22} nvt have been examined. For at least some of their total residence in the reactor, the elements were irradiated at higher temperatures (i.e., 1080°F maximum) than in the past, because of the increase in the operating power of the reactor from 50 to 62.5 MWt. As reported previously,³ the cladding became sensitized in the higher-temperature regions of the element, but showed no evidence of selective attack by the sodium environment or of any microstructural changes that could be attributed to the reactor environment or the sodium-removal procedure. Figure 20 shows a typical microstructure of element cladding that had been irradiated at a calculated temperature of 1065°F.

Fig. 20. Cladding from Element 26, from Subassembly B-3079, Exposed at a Calculated Temperature of 1065°F (etched in 10% oxalic acid). Mag. 175X.

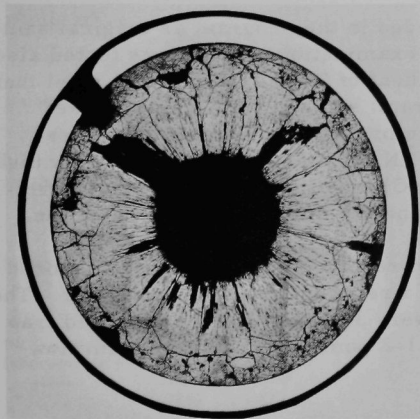
diameter) was completely filled with sodium. Figure 22 shows a cross section of the sample through the midlength of the defect. The relatively large void areas are not unique to this sample, but have been observed in the structure of other elements examined after irradiation. The depth of the defect is approximately the same as that before exposure, and the examinations to date have revealed no discernible effects of the sodium exposure. Microprobe analysis will be attempted to determine if any products of reaction of sodium and fuel were produced.

Fig. 22. Transverse Section of Defected Sample from Fuel Element 007 after Exposure to 700°F Sodium for 28.8 days. Mag. $9.75\times$. Neg. No. MSD-1432B.

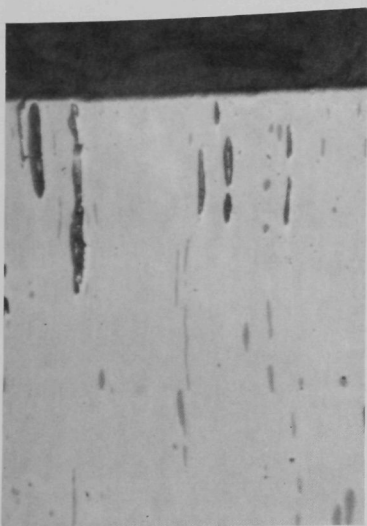
had dissolved the stringers of second-phase material (when stringers were interconnected) to depths up to 0.03 in. after 35 days of exposure (see Fig. 23).

Fig. 23. Penetration of Type 303 Stainless Steel
Exposed 35 days to 3-fps Flow of 700°F
Sodium. Mag. 450X.

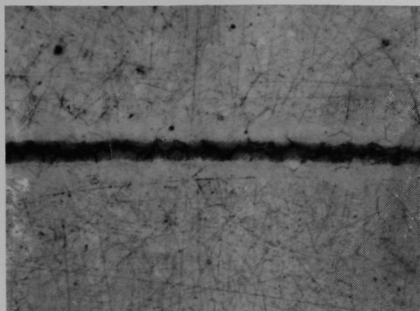
Negligible weight changes (± 0.0001 g) were recorded for the sodium-exposed samples. Microscopic examination of the braze area indicated that the plugs were not evenly centered in the hole and that most of the diametral clearance accumulated on one side of the plug. The braze in the center of this wider band was attacked slightly by the sodium (see Fig. 24). No sodium attack was noted in the low-clearance regions of the joint or the adjacent diffusion zone in the stainless steel (see Fig. 25). The sodium exposure also brought out surface scratches on the previously metallographically polished stainless steel surface, as can be seen in the figures.

Fig. 24. Appearance of Wider Brazed Joint after Sodium Exposure. Mag. 135X.

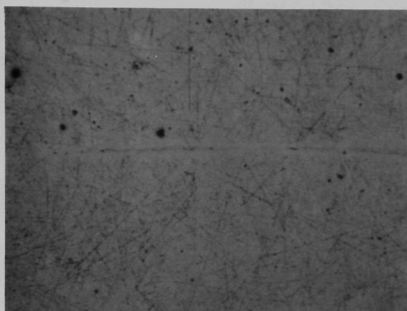
Fig. 25. Appearance of Low-clearance Region of Brazed Joint after Sodium Exposure. Mag. 135X.

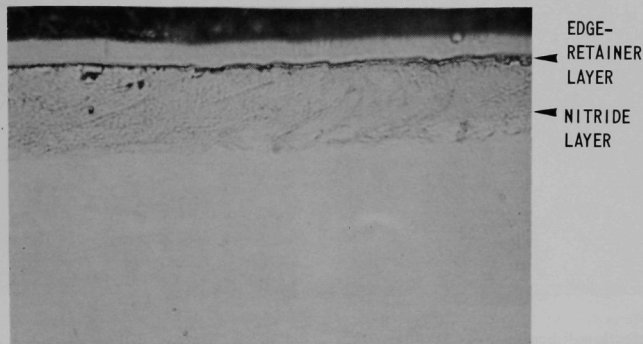
were exposed to the nitrogen atmosphere above the sodium. After exposure, metallographic examination of the foils revealed dense, continuous nitride layers extending to a depth of 0.4 mil into the foils exposed to the sodium and 0.7 mil into the foils from the cover-gas region. Figure 27 shows the nature of the nitride layer in a nitrogen-exposed foil.

Fig. 27. Nitrided Layer on Type 304 Stainless Steel after One week in Nitrogen Gas Space above 1020°F Sodium (as polished). Mag. 900X.

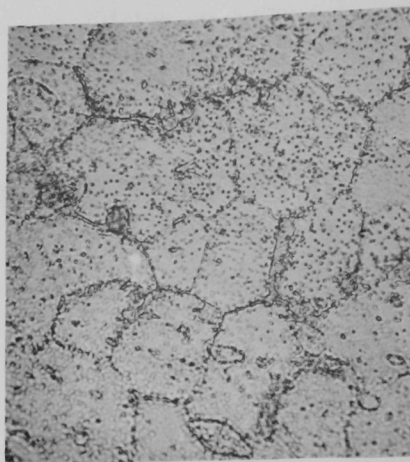
Fig. 29. Electropolished Type 304 Stainless Steel Surface Exposed to 1020°F Sodium under Ar-0.1 vol % N_2 Cover Gas. Mag. 900X.
